Restricted Appraisal Report

Former Westside Market
729-741 N. Central Avenue
Tracy, CA 95376
APN: 235-068-06

Downtown Brewpub / Restaurant Project

City of Tracy

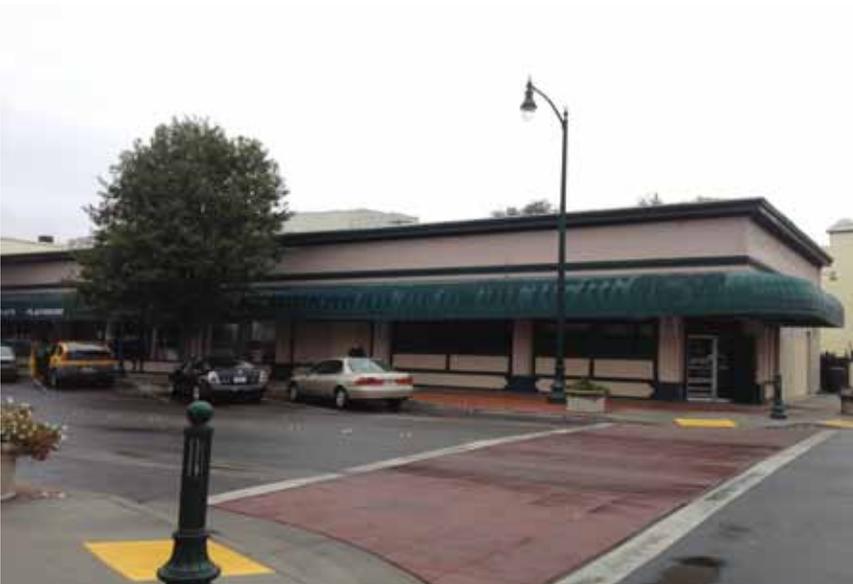
The Westside Market was formerly entered from the corner of Central Avenue and Eighth Street.

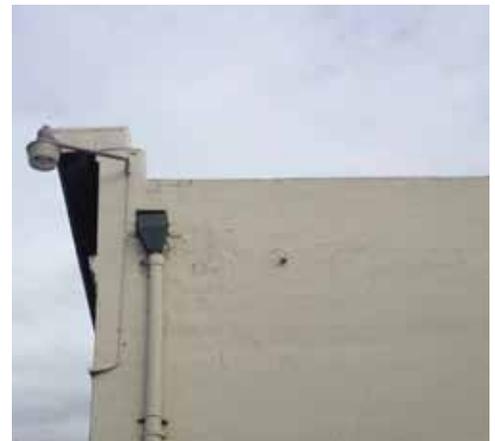
The roof cornice at the north west corner of the building is slightly sagging and need additional support

- Replace existing parapet flashing with new flashing.
- Repair and structurally reinforce Cornice at north-west corner of building which is sagging.
- Provide (1) layer of Type X gyp board to underside of ground floor framing to provide (1) hour fire separation between basement and ground floor.

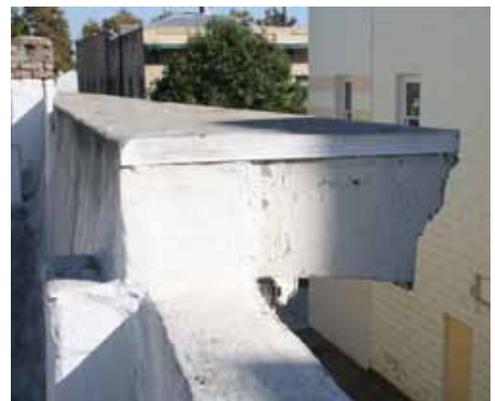
Cornice detail

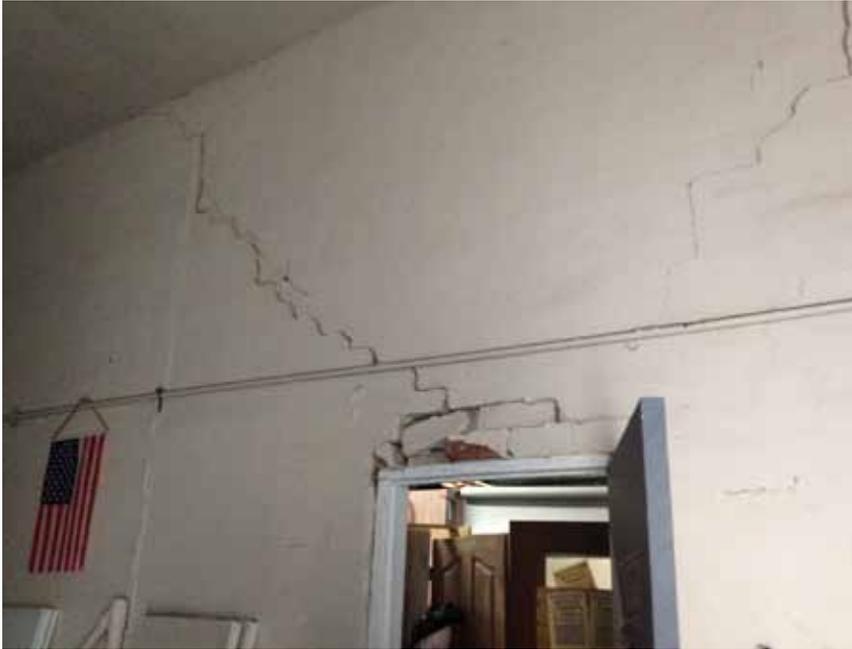
Diagonal cracking in brick masonry walls at rear addition

The “addition” is lacking a full basement and the roof is supported by perimeter and interior brick bearing walls. The addition’s bearing walls has diagonal cracks and the addition appears to be settling differentially from the original building.

In reviewing the condition of the existing facility, the consultancy team felt that the "addition" at the rear of the building should be removed as its renovation cost would exceed the cost of a new replacement. In addition, the wooden storage shed should be removed as it has little value. It is recommended that the original building structure (6,168.5 square feet) be retained and that additions, non-structural interior partitions, interior finishes and outdated MEP systems be removed.

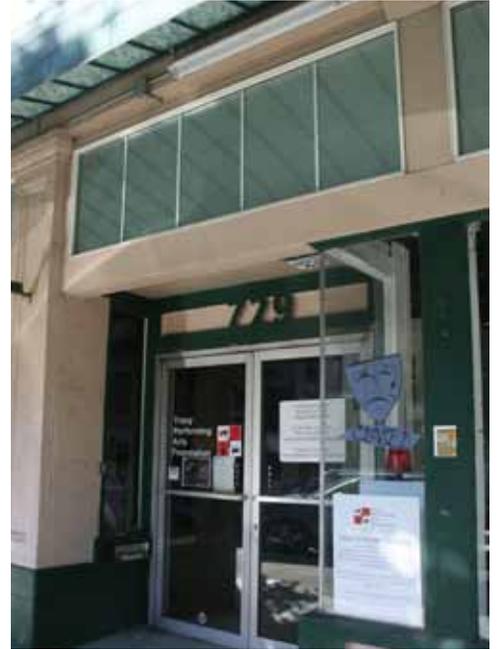
Aluminum storefront and wood infill between plaster covered concrete columns

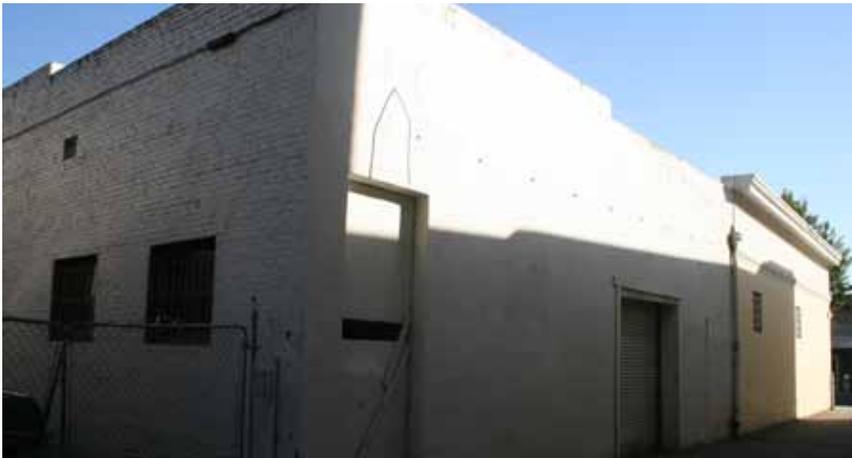
The brick at the rear addition is mostly left exposed and painted

The exterior of the concrete and brick walls are covered with cement plaster, except for the west and north walls of the addition in which the brick is exposed and painted. The Central Avenue façade consists of single pane aluminum storefront windows and wood panels between cement plaster covered concrete columns. There is a green fabric awning which extends the length of Central Avenue, and a portion of Eighth Street. These awning cover the existing clearstory windows. As would be expected of an older structure, the paint over the stucco has built up over the years, and is separating or bubbling from the cement plaster in several areas. The wood infill between the exterior concrete columns have shrunk in several areas causing gaps between the infill and the columns.

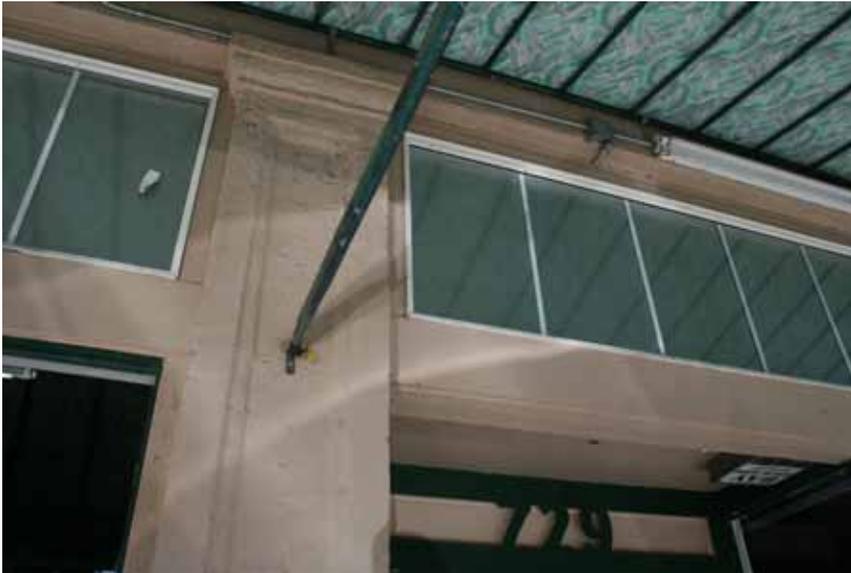
The existing awnings are covering the clearstory windows

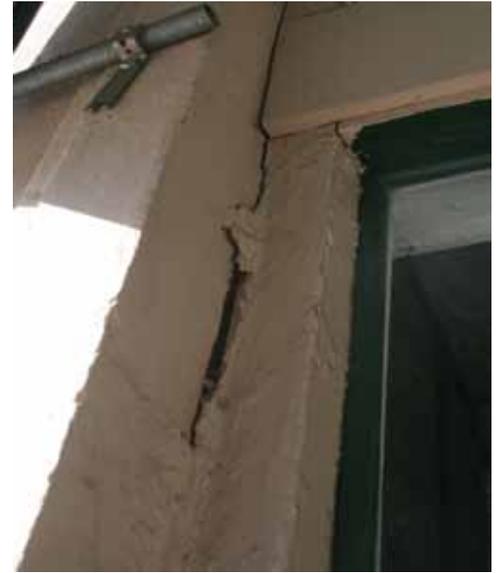
The wood infill between the concrete columns along Central Avenue have shrunk causing gaps in several areas

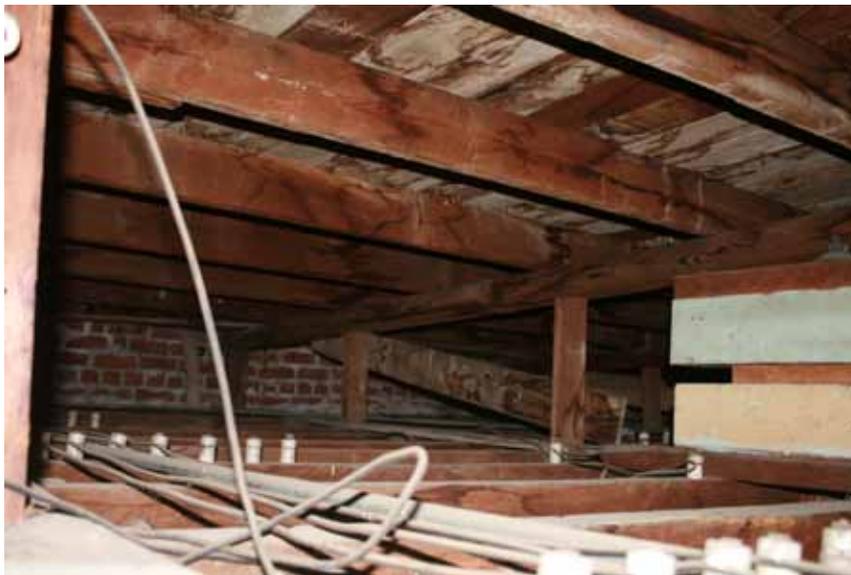
There is a shallow attic space between the roof and ceiling joists

The roofing system consists of a shallow wood framed attic. The top portion of the attic is sloped and supports the roof sheathing above. The lower portion of the attic is horizontal and either cement plaster or gyp board is adhered to the bottom to form a ceiling.

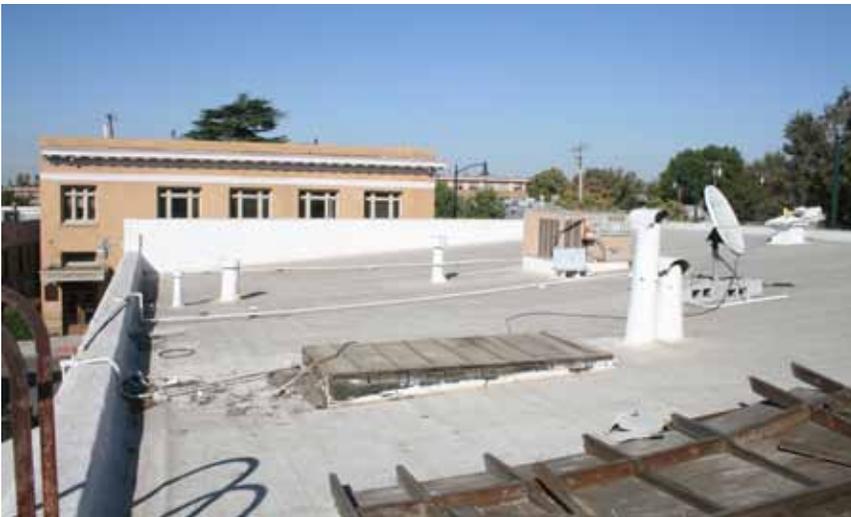
Single ply white roofing membrane

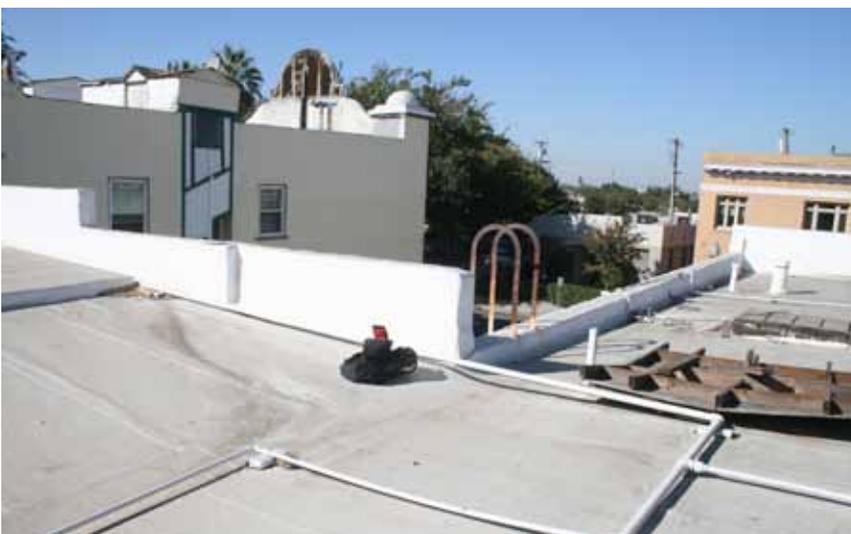
The single ply roofing has lost adhesion in several areas. Note bubbling in valley and to left of valley.

- Provide (1) main electrical room accessible from rear alley, (1) fire service riser room accessible from rear alley.
- Replace existing roof membrane with new TPO single ply roof over R-30 rigid insulation.

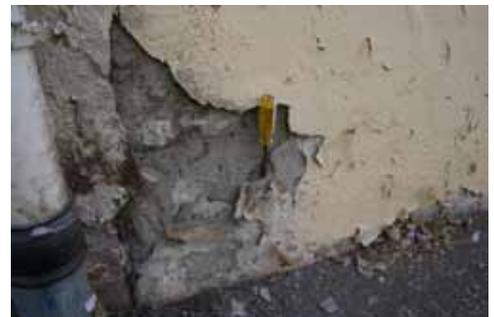
Sand blast paint off of existing walls and remove loose plaster.

- Sandblast paint off of existing cement plaster walls, remove loose cement plaster, repair plaster including re-detailing of decorative columns and building corners, prime, add elastomeric (VIP) undercoating, and 2 coats of acrylic latex paint.

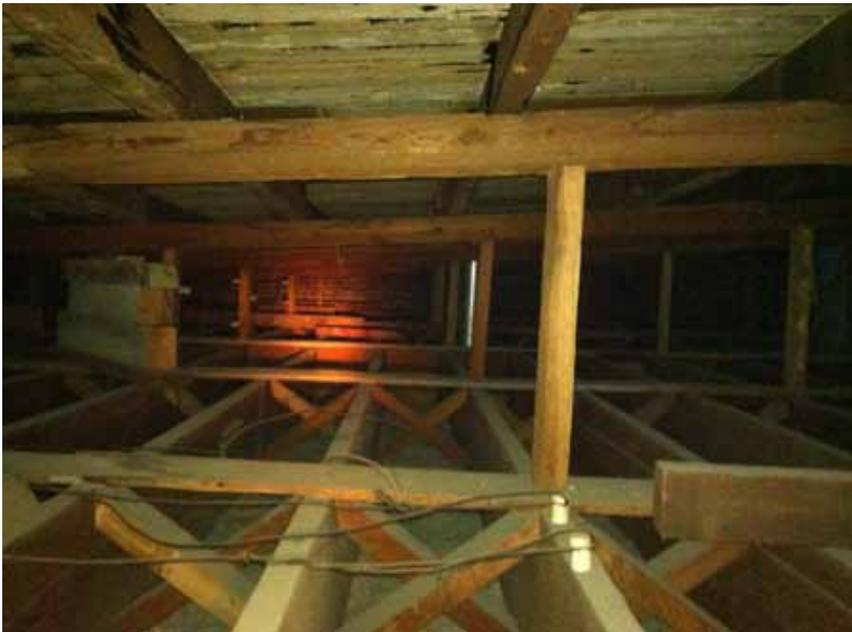
2x6 roof rafters at 24"oc running the long direction of the building create the sloped roof framing. 2x sloped stud 'pony' walls at 8'oc support the 2x6's. The pony walls are supported by 2x14 flat ceiling joists at 16"oc running the long direction of the building. The ceiling joists are supported by girders or transverse bearing walls at approximately 20'oc.

Typical roof and ceiling framing

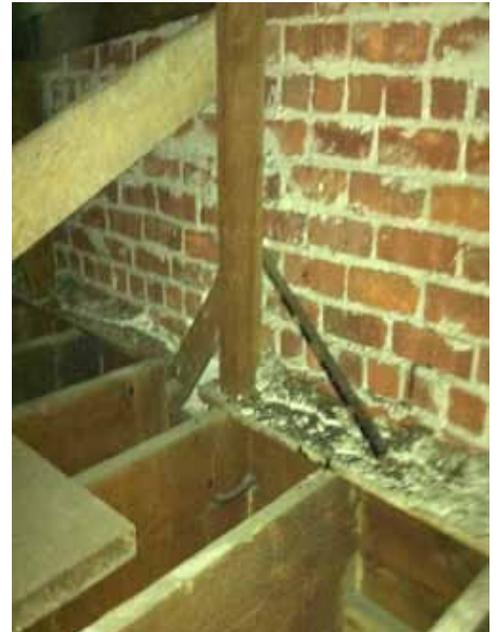
Brick parapet above concrete wall at ledger with wall anchor

The perimeter walls are cast-in-place concrete. Reinforcing in the concrete walls is unknown. The concrete walls extend to the top of the ceiling joists. Brick parapets extend above the top of the concrete walls above the ceiling joists.

- Provide parapet bracing where parapet extends 18" or more taller than roof framing
- Investigate, test, and evaluate existing basement wall and foundations for strength

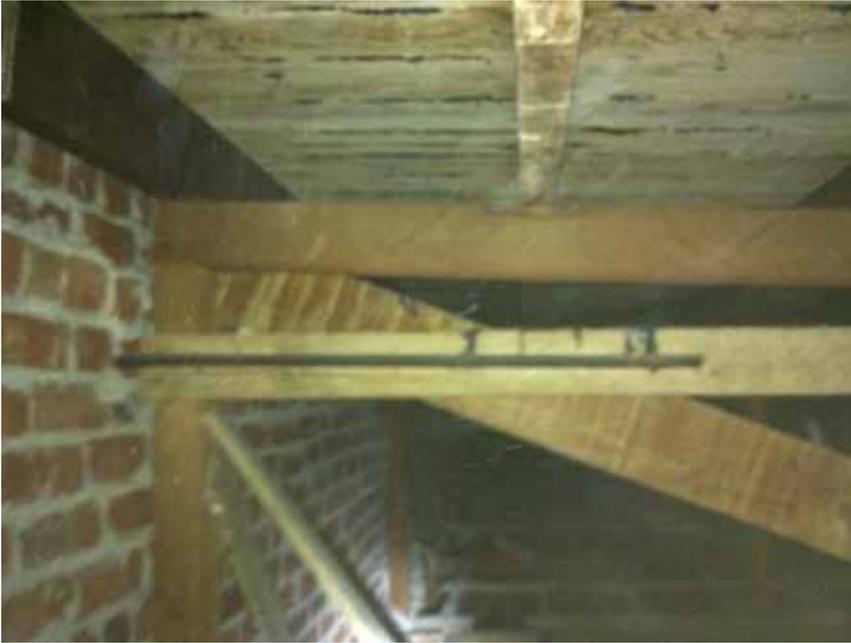
The ceiling rafters are anchored to the top of the concrete walls with 'government anchors' at 4' to 8'oc irregular spacing. The roof rafters are anchored to the brick parapet with government anchors at approximately 8'oc. Some government anchors have bearing plates at the exterior of the walls which perform better than embedded anchors. Bearing plates were not able to be verified in the field due to trim and finishes. Government anchors provide a minimal level of wall anchorage but the mechanism and connections are archaic compared to current wall anchorage requirements.

Wall anchor at roof framing

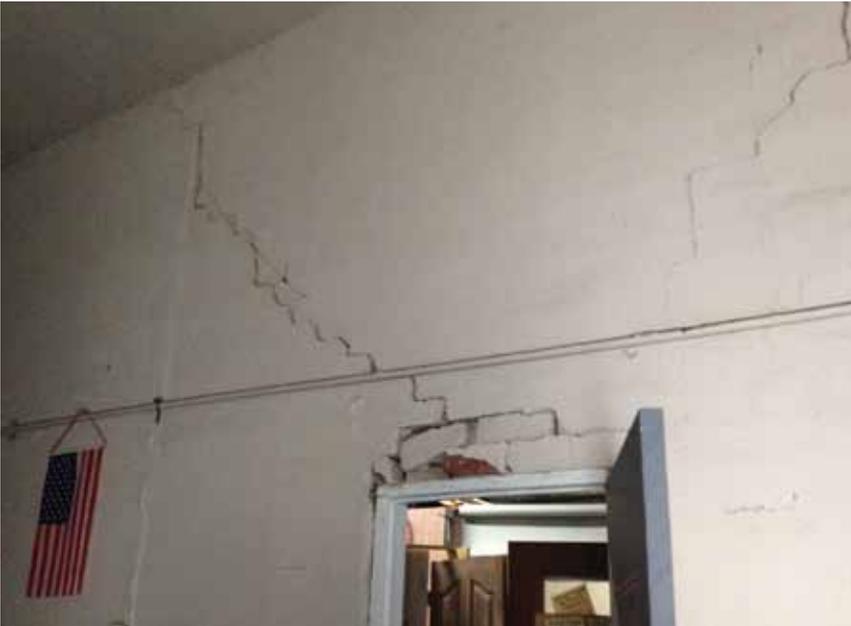
Diagonal cracking in brick masonry walls at rear addition

The addition portion at the rear of the building is constructed of similar roof framing and wall anchorage construction. However, the addition walls are brick masonry. Based on the cracking that has occurred in the walls, the masonry is assumed un-reinforced. The ground floor is concrete slab-on-grade with marginal performance and cracking. There is no basement at this area and foundations are assumed to be shallow spread footings. This portion of the building is in dis-repair and exhibits diagonal cracking in numerous locations. This portion of the structure is a liability.

A key finding of this study is that the existing building's foundations are resting on a 12 to 13 foot layer of silty sand. This sand layer is subject to liquefaction during a seismic event. It is probable that the distressed condition of the rear "addition" has been caused by the differential settlement of the silty sand below the building. The damage to the addition is significant, and it is the opinion of the consultancy team that the cost of repairing the addition exceeds the cost of a new structure.

- Remove existing 2,716.5 square foot addition, and 290 square foot shed at rear of building. Add new exterior wall on column line C between lines 4 and 8 consisting of 7/8" cement plaster over exterior sheathing board over 6" structural steel stud framing.

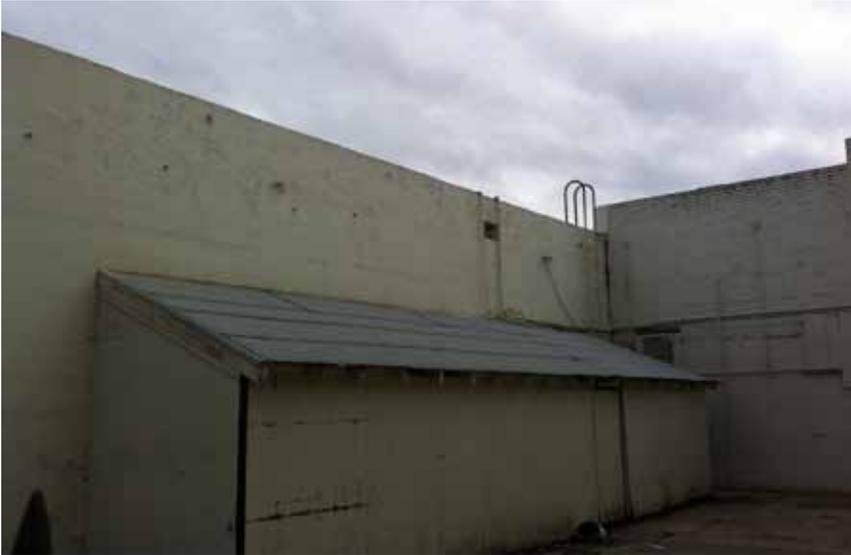
The wood framed shed at the rear of the building is in significant dis-repair, supplies no structural value to the building, and is a liability.

Wood shed rear addition

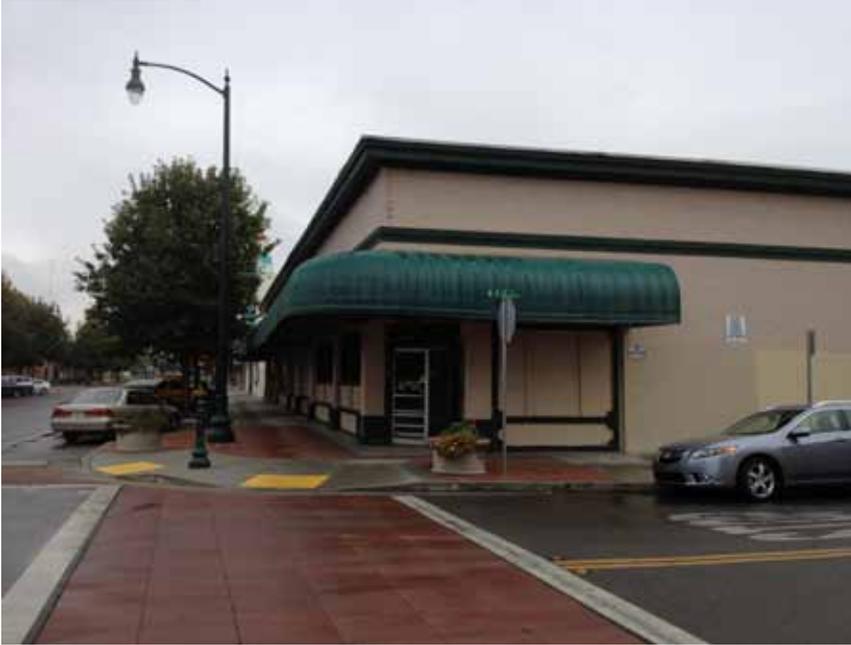
The parking along Central could be removed and replaced with an exterior dining area

- Removal of the parking directly in front of the property along Central Avenue and replacement with an outdoor dining area consisting of a low decorative fencing along three sides, brick paving, street lights, and additional trees.
- Removal of the fabric awning which is currently obstruction the clearstory windows. Replacement with metal canopies at an 8 ft high elevation that allow light to enter the tenant spaces from the clearstory windows.
- Providing deeper and enlarged recessed storefront entrees.
- Provide additional articulation and material enhancements to facades.
